Efflorescence – Causes and Prevention

Abstract: This *Technical Note* describes the mechanisms leading to the formation of efflorescence, including probable sources of soluble salts and moisture. Conditions necessary to cause efflorescence to appear are presented, along with design recommendations and practices that reduce the potential for efflorescence.

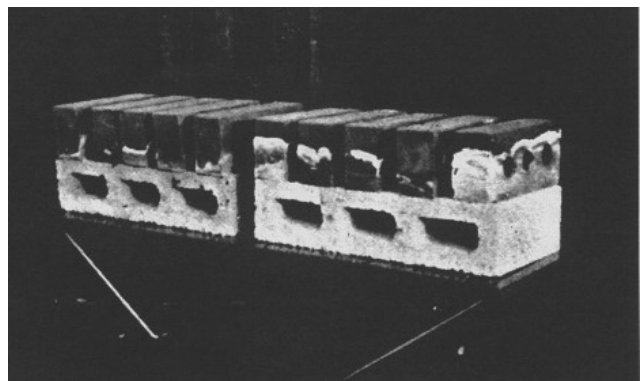
Photo 2
Migration of Soluble Salts from Backing to Brick

Photo 2 illustrates the transfer of soluble salts from CMU backing units to brick when the two materials are in direct contact. This result was obtained by placing the CMU in pans of water with five brick units on top of each block. The brick units had previously been subjected to the efflorescence test and rated “not effloresced” [Ref. 1]. The potential for backing materials to effloresce can be determined by using the

same efflorescence test method used for brick. The barrier wall strategy of filling a collar joint between masonry wythes with mortar or grout to provide a continuous barrier to water penetration is not recommended. Because mortar and grout contain cement, collar joints increase the potential for efflorescence by placing a source of salts in direct contact with the brickwork.
